INDOOR AIR QUALITY ASSESSMENT

**Department of Transitional Assistance
72-100 Front Street
Holyoke, Massachusetts**

Prepared by:
Massachusetts Department of Public Health
Center for Environmental Health
Emergency Response/Indoor Air Quality Program
July 2005

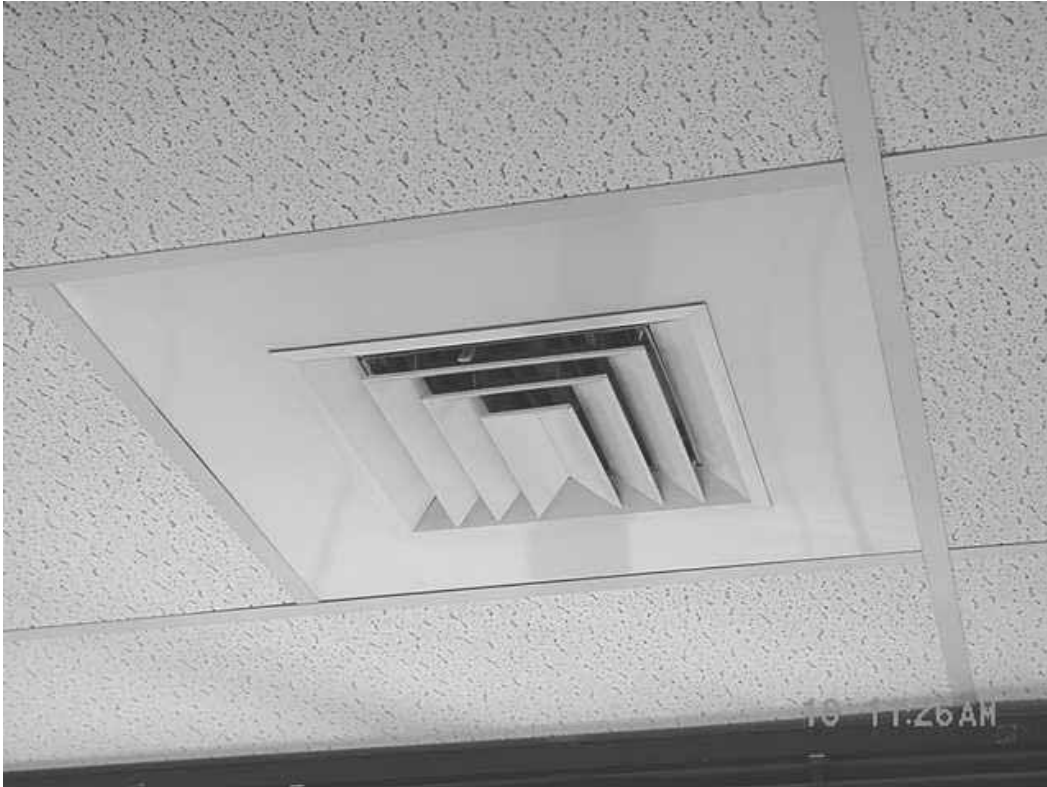
Picture 1

It can be seen from Table 1 that carbon dioxide levels were below 800 ppm (parts per million) in all areas surveyed, indicating adequate ventilation. A heating, ventilating and air conditioning (HVAC) system, which consists of rooftop air handling units (AHUs) ducted to ceiling-mounted supply and return vents (Pictures 1 and 2). This system was operating throughout the building on the day of the assessment.

Ceiling-Mounted Supply Diffuser

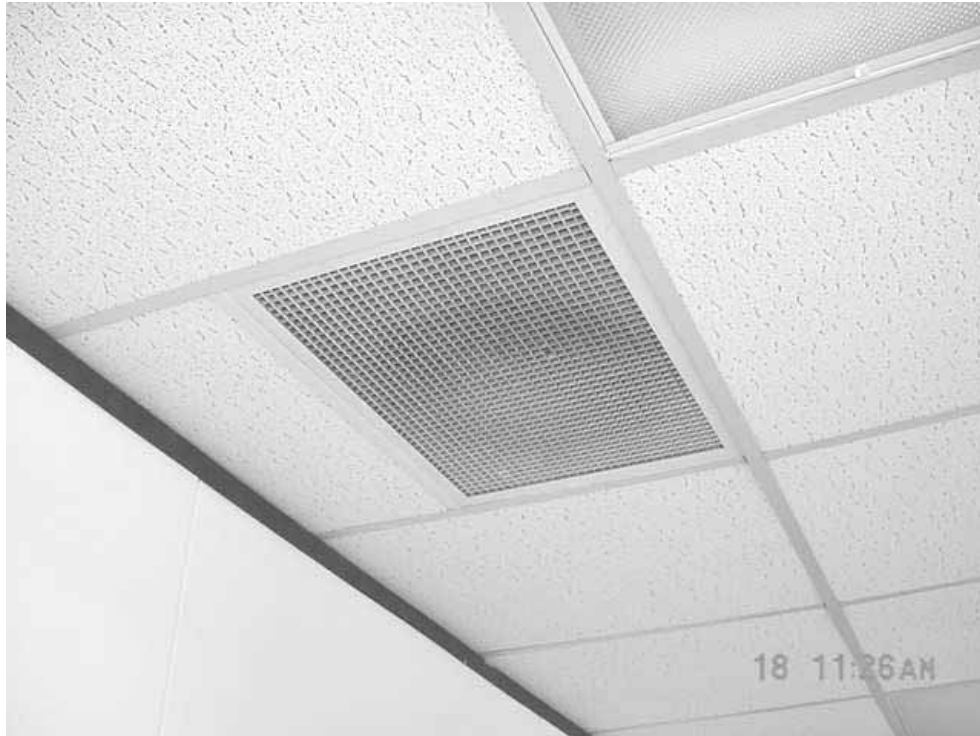
Picture 2

Ceiling-Mounted Return Vent

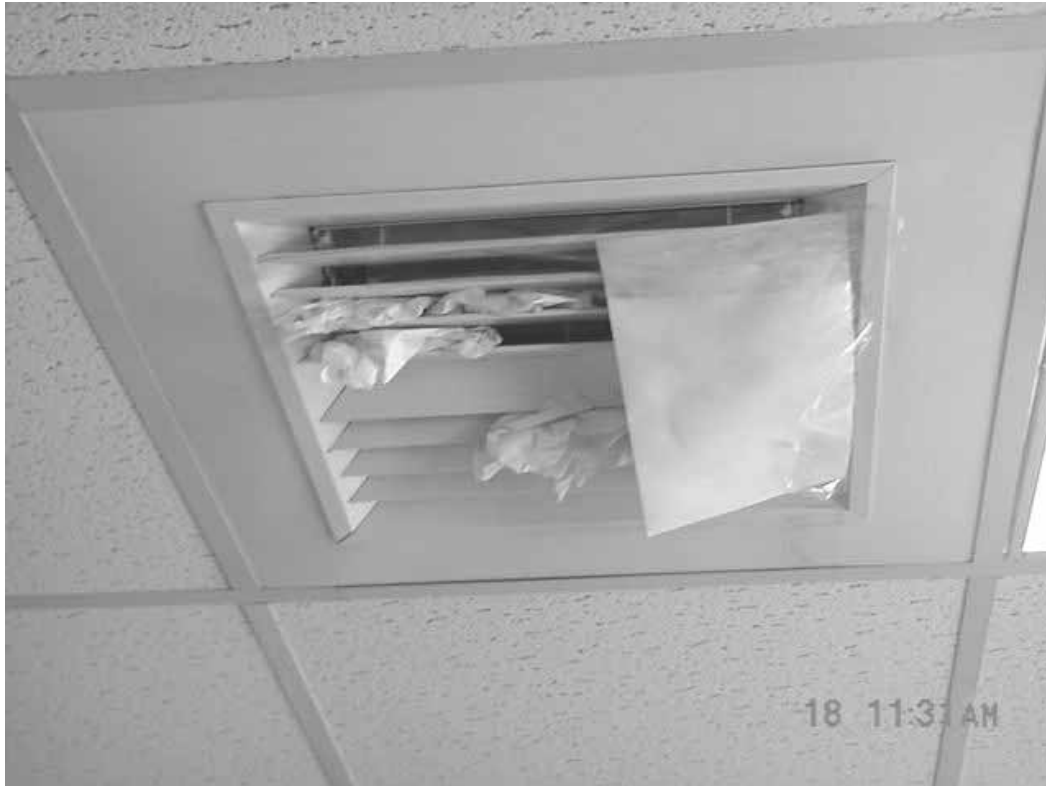
Picture 3

the comfort of building occupants. In many cases concerning indoor air quality, fluctuations of temperature in occupied spaces are typically experienced, even in a building with an adequate fresh air supply. In work location 246, a ceiling-mounted supply diffuser was stuffed with paper towels and deflected with cardboard and tape (Picture 3), reportedly to control drafts. This alteration, however, can throw the ventilation system off-balance and create uneven heating/cooling conditions in other areas adjacent to the blocked diffuser.

Supply Air Diffuser Stuffed with Paper Towels and Deflected with Cardboard and Tape

1. Repair/replace restroom exhaust motors as necessary.
2. Remove all obstructions from supply vents.
3. Ventilation industrial standards recommend that mechanical ventilation systems be balanced every five years (SMACNA, 1994).
4. For buildings in New England, periods of low relative humidity during the winter are often unavoidable. Therefore, scrupulous cleaning practices should be adopted to minimize common indoor air contaminants whose irritant effects can be enhanced when the relative humidity is low. To control for dusts, a high efficiency particulate arrestance (HEPA) filter equipped vacuum cleaner in conjunction with wet wiping of all surfaces is recommended. Drinking water during the day can help ease some symptoms associated with a dry environment (e.g. throat and sinus irritations).

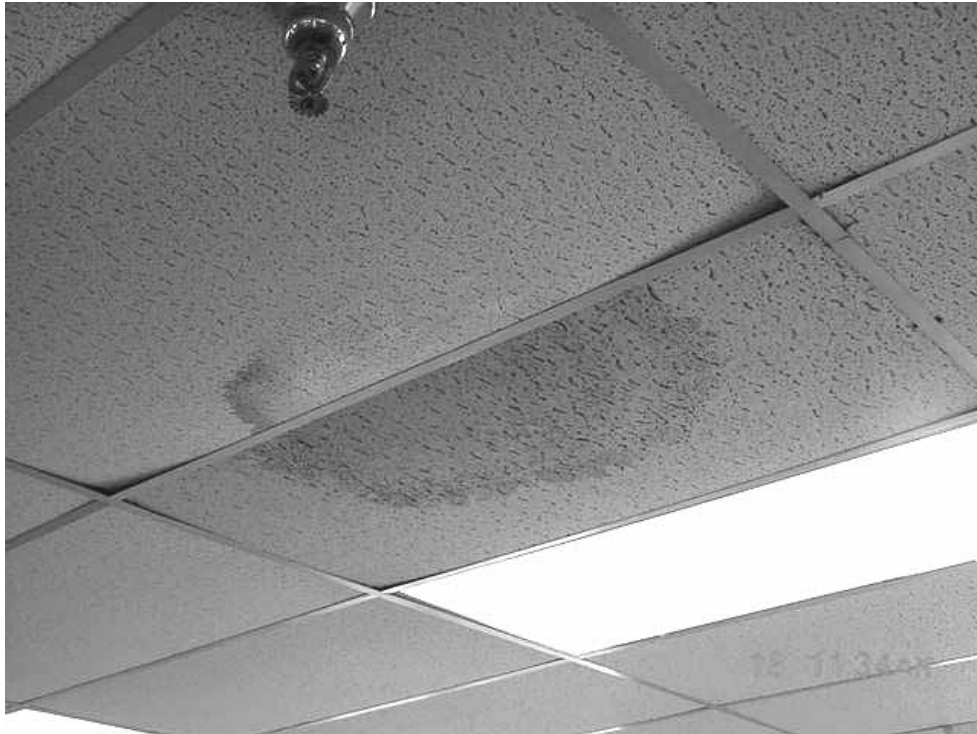
Picture 4

A few areas had water damaged ceiling tiles (Picture 4). Water damaged ceiling tiles can provide a source of mold and should be replaced after a moisture source or leak is discovered and repaired. Water coolers were observed on carpeting (Picture 5). Water spillage or overflow of cooler catch basins can result in the wetting of the carpet. In addition, some of the coolers had residue/build-up in the reservoir. These reservoirs are designed to catch excess water during operation and should be emptied/cleaned regularly to prevent microbial and/or bacterial growth.

Water Damaged Ceiling Tiles

5. Ensure water leaks are repaired and replace water damaged ceiling tiles. Examine the non-porous surface beneath the removed ceiling tiles and disinfect with an appropriate antimicrobial.
6. Ensure plants have drip pans. Examine drip pans periodically for mold growth and disinfect with an appropriate antimicrobial where necessary.
7. Relocate or place tile or rubber matting underneath water coolers in carpeted areas. Clean and disinfect reservoirs as needed to prevent microbial growth.
8. Clean supply/return vents periodically of accumulated dust.
9. For further building-wide evaluations and advice on maintaining public buildings, see the resource manual and other related indoor air quality documents located on the MDPH's website at <http://www.state.ma.us/dph/beha/iaq/iaqhome.htm>.

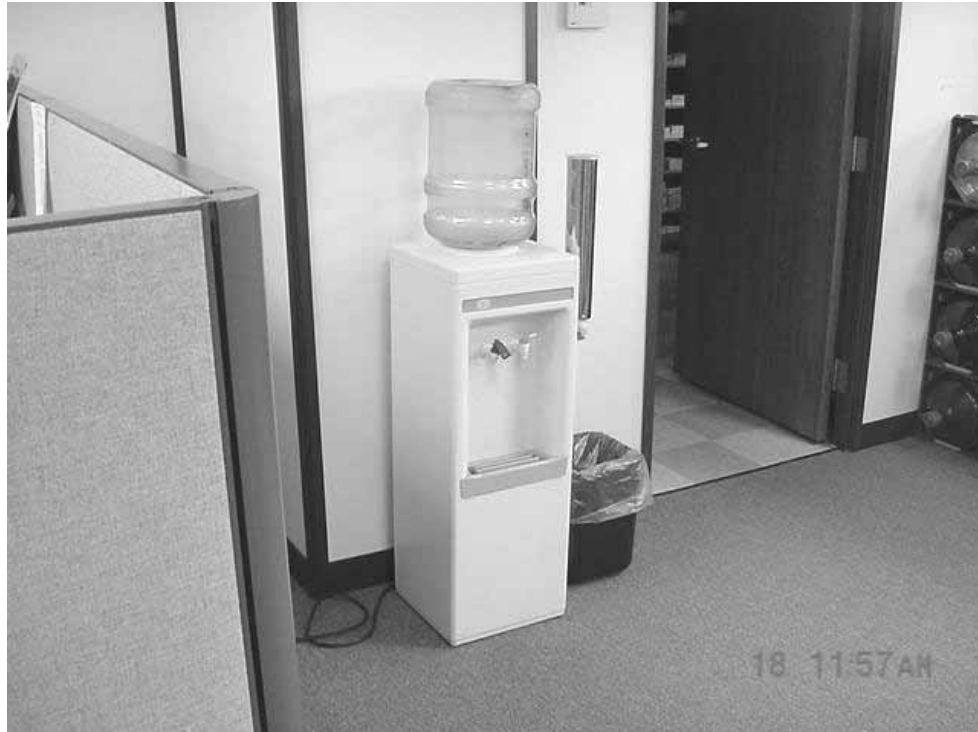
Picture 5

Water Cooler on Carpeting

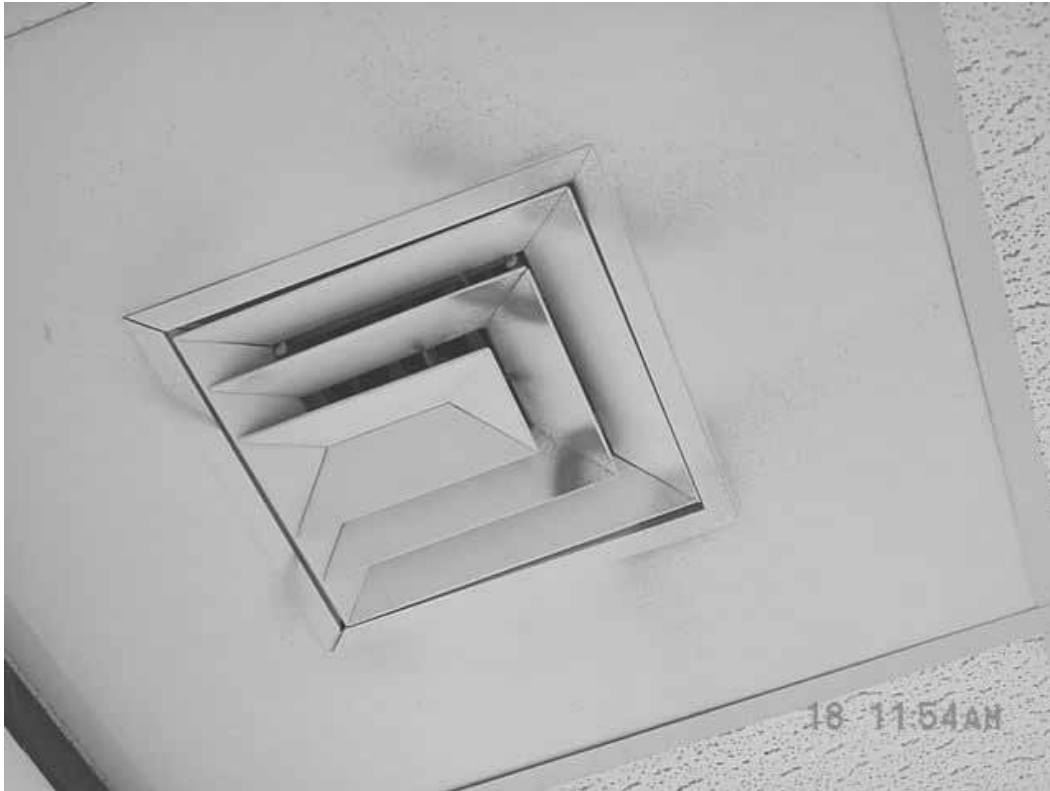
Picture 6

A number of supply and return/exhaust vents had accumulated dust (Pictures 6 and 7). If exhaust vents are not functioning, backdrafting can occur, which can aerosolize dust

particles. In addition, these materials can accumulate on flat surfaces (e.g., desktops, shelving and carpets) in occupied areas and subsequently be re-aerosolized causing further irritation. Dust can be irritating to eyes, nose and respiratory tract.

Dust/Dirt Accumulation on Supply Air Diffuser

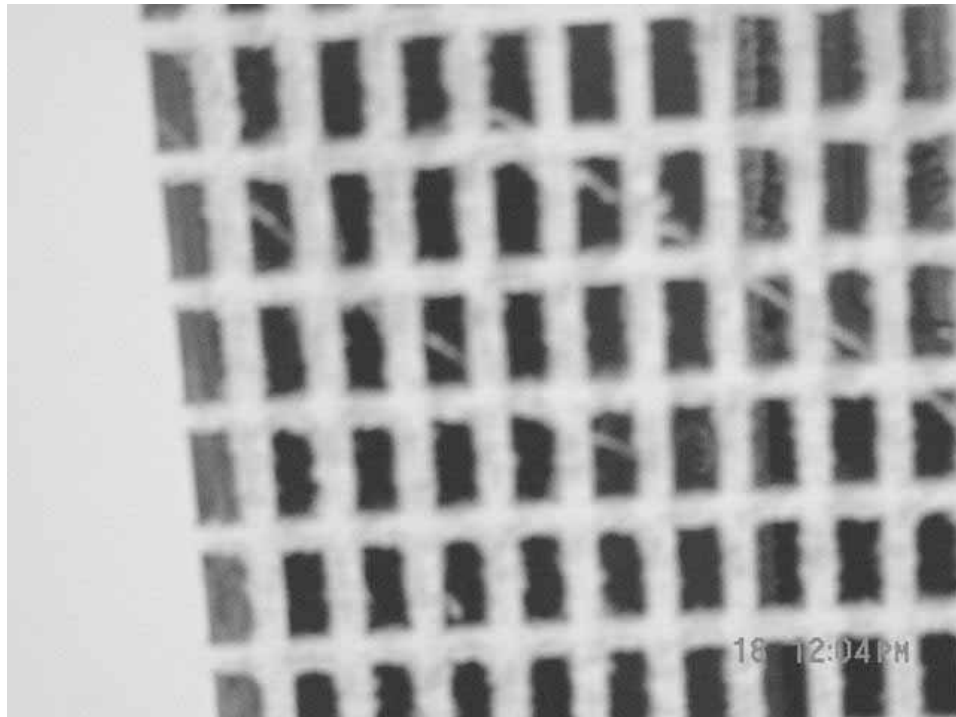
Picture 7

Dust/Dirt Accumulation on Return/Exhaust Vent
